## **MEMORANDUM**

**TO:** Heritage Preservation Commission  
**FROM:** John Smoley, Kevin Carroll, and Steve Maki, CPED  
**DATE:** February 15, 2011  
**RE:** Legacy Amendment Grant Update, Grain Belt Office Building

**SUBJECT:** Grainbelt Office Building Drainage Study  
Loucks Project No.: 05-051B

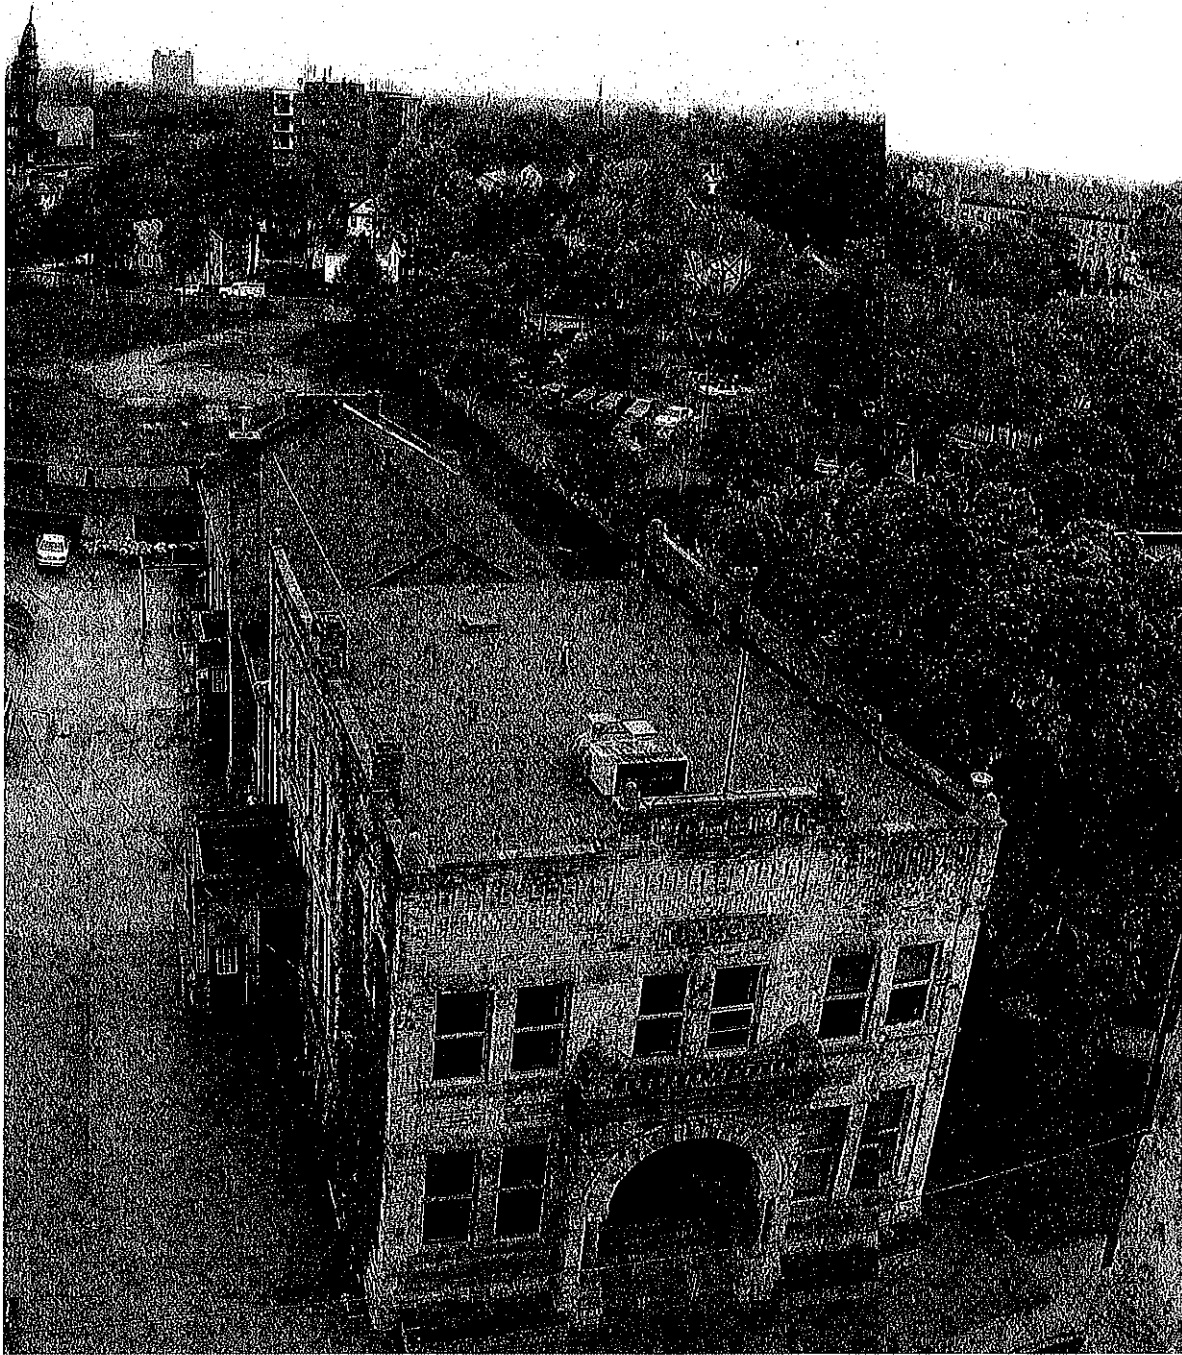
**Figure 2. 1215 Marshall Street Northeast, 1972, source: CPED**

- Phase IV involves replacing nonhistoric roofing materials, last replaced in 1983, on the two eastern portions of the roof to stop water infiltration to the upper levels of the building. These portions are the peaked roof on the addition and the flat roof on the connector between the addition and the original office building (Figure 2).
